**Jacobs Vehicle Systems™**

## **Jacobs Exhaust Brake™ Service Letter X10**

**SUBJECT: Outlet gasket required for certain vehicle manufacturer installations**

**MODELS AFFECTED: EXISC Full-Marmon Turbo Mount**

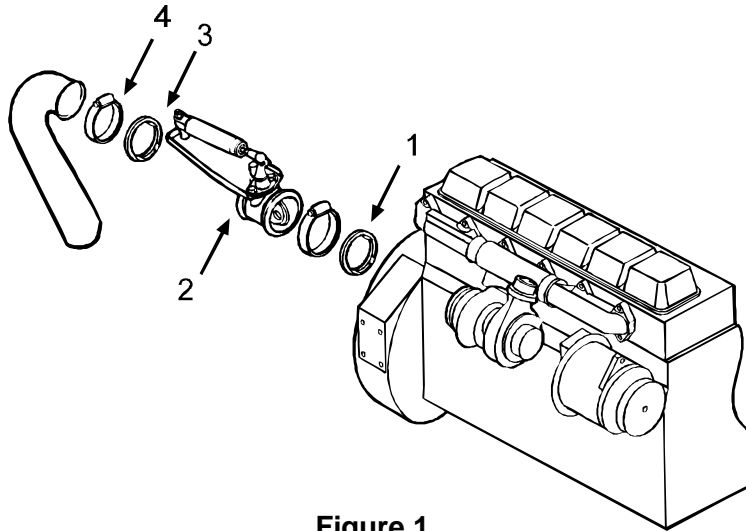
Figure 1

The use of thin wall exhaust pipe material by some vehicle manufacturers requires the installation of a gasket on the outlet side of the exhaust brake. If a gasket is not installed when thin-wall header pipe is used, the V-clamp may not fully seal the outlet joint, allowing exhaust gases to escape into the engine compartment.

Whenever removing an exhaust brake assembly from an ISC turbo-mount model, determine whether there is a gasket (3) installed on the outlet side (2) of the brake assembly. If there is a gasket, this gasket must be replaced with a new gasket when the assembly is reinstalled. **NOTE:** The inlet side gasket (1) must also be replaced with a new gasket whenever the assembly is removed for service.

If there is NOT a gasket on the outlet side of the exhaust brake assembly, a new gasket should not be required. However, when the assembly is reinstalled, check the V-clamp (4) when it is tightened to make sure the ends of the clamp do not contact each other before the proper torque is applied to the clamp nuts. The correct torque for the clamp nuts is 70 - 80 lb-in. (8 – 9 N•m). If the ends of the clamp meet before the proper torque has been applied, a gasket is required in this joint.
